CARE Suffolk

Ref: DC/21/05468 Full Planning Application - Construction and operation of a 100MW Battery Energy Storage System, and related infrastructure with associated access, landscaping and drainage. Land to the South of Bullen Lane Bramford, Suffolk, IP8 4JD.

CARE Suffolk Report for DC/21/05468

Full Planning Application - Construction and operation of a 100MW Battery Energy Storage System, and related infrastructure with associated access, landscaping and drainage.

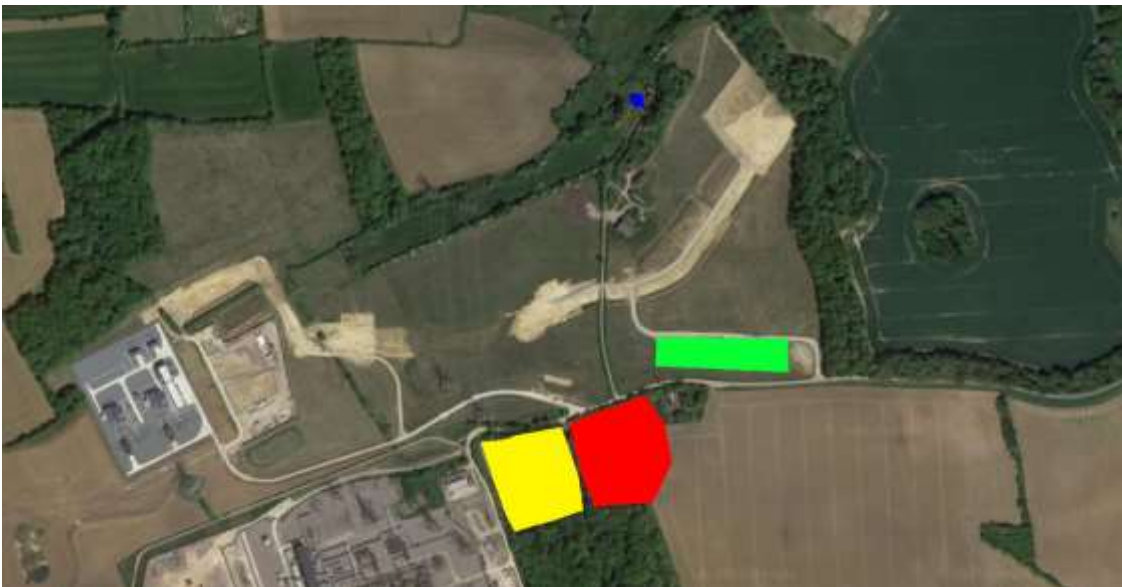
- a) Another BESS (DC/19/03008 and yellow area on Image 1 below) was granted planning permission for the field immediately west of the site, but it is not yet built. Because it is not yet built the noise levels from this development are not in the measured recordings. But they have also not been taken into account when forecasting the new noise levels.
- b) A gas generation system (DC/19/00046 and green area on Image 1 below) is also approved for a field opposite Bullen Lane, but is only partially constructed and as such not yet operating. Because it is not yet operating the noise levels from this development are not in the measured recordings. But they have also not been taken into account when forecasting the new noise levels.

2.4 The measured readings used as the basis for the noise report are therefore not reliable as a baseline.

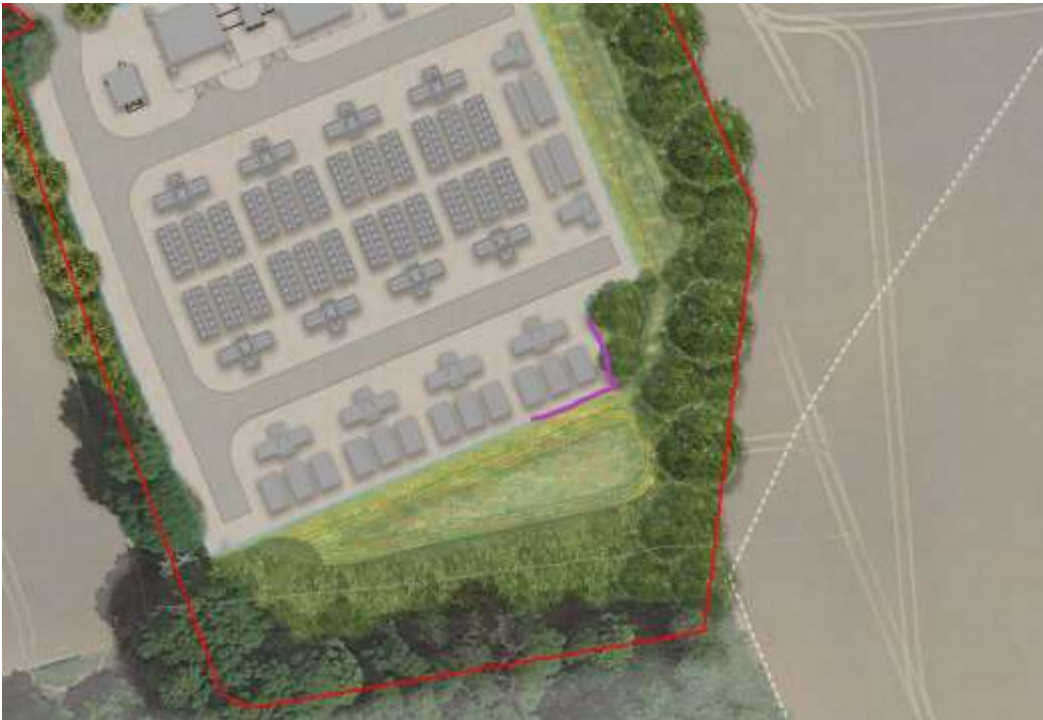
Image 2 – proposed blast wall shown in purple to protect users of PRow.

- 7.19 One of the heavy duty doors have been blown off its hinges and thrown 23m away.
- 7.20 However, instead of blast walls in between each rack, we ask that a blast wall be placed around three of the battery racks (see Image 2 below). If the Council were minded to approve the application, the inclusion of this feature would act as an extra safety barrier to users of the adjacent PRow.

- 7.21 The PRow is approximately 30m away from the nearest proposed battery rack and the lighter components of this have the potential to be thrown further than the door was in Merseyside.
